Manhole Inspection Summary

Manhole # S55G__010MH

Insp Date: **7/29/08 8:39 AM**

Location Address: **rear 3701 claremont av**

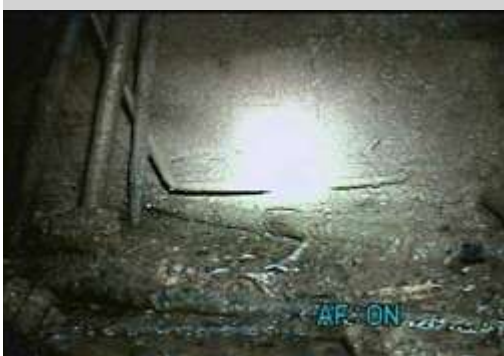
Defect 3

Condition: ☐ Sound ☐ Cracked ☐ Root Intrusion ☐ Deteriorated ☐ Leaks ☒ **Debris**

channel debris

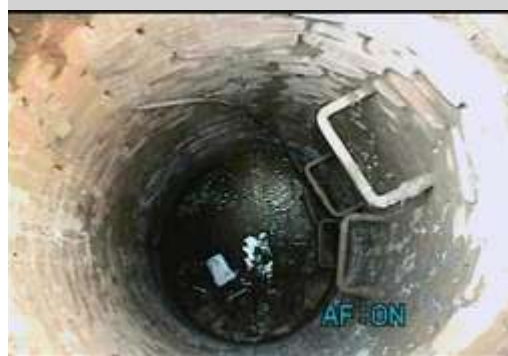
Defect 2

Count: **5** Missing: **0** ☒ **Corroded**

steps

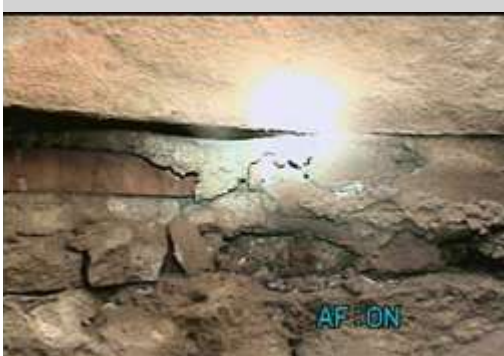
Defect 1

Condition: ☐ Sound ☐ Cracked ☐ Root Intrusion ☒ **Loose Brick** ☒ **Deteriorated**

Infiltration: ☐ None ☒ **Joint** ☐ Cracks ☐ Mortar ☐ Roots ☒ **Wall**

Loose Brick & Det, infiltration

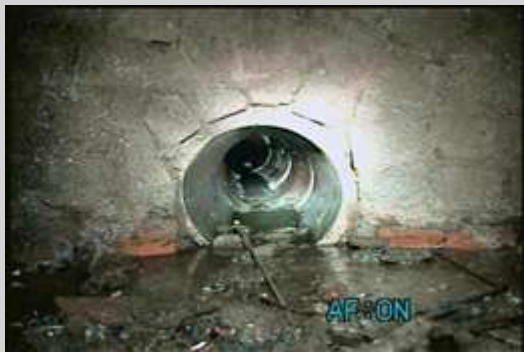
12 O'Clock Outflow

8 in. Circular Gravity Sewer
Pipe Out @ 12 O'Clock

Deposits: ☒ None ☐ Mud ☐ Sludge ☐ Debris ☐ Grease

Infiltration: **None** Pipe Seal Cond: **Unknown**
